**An Archaeological Evaluation of a collapsed
culvert in the gardens of Wrest Park Silsoe
Bedfordshire.**

March 1997

Archaeological evaluation of a collapsed culvert in the gardens of Wrest Park Silsoe.
March 1997

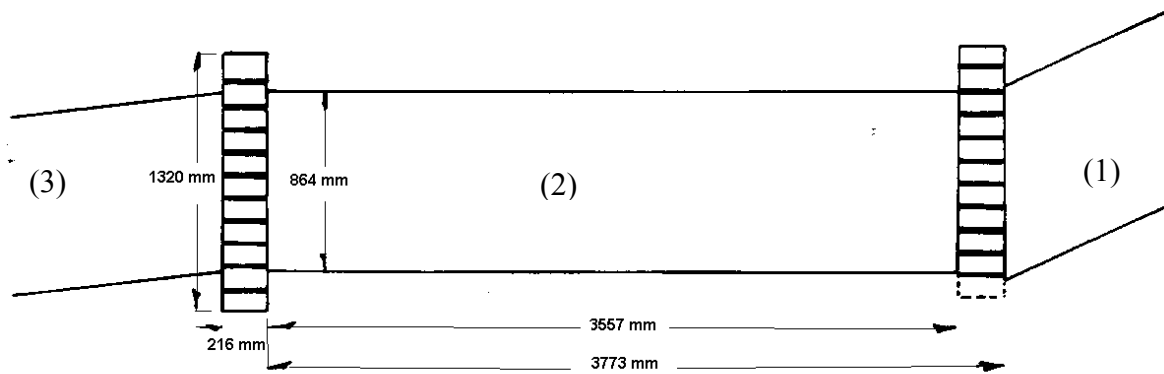
4.2a Excavation near the apparent change of direction revealed that the culvert (1) joined with another culvert (2) that had a different alignment and was at a lower level, its upper surface being approximately 200 mm below that of culvert (1). Culvert (2) was of similar construction to but predated culvert (1). A third culvert (3) joined with culvert (2) and continued on the original alignment of culvert (1) with a similar fall of approximately 1:20. (fig.1).

Careful study of the culverts (1), (2) & (3) indicates that culvert (2) was probably in position before (1) and (3) were built, No (2) had no discernible fall. This together with the length 3557mm (11.6 feet) and the up-stands at each end suggest that the culvert was in fact the arch of a small bridge. Culverts (1) and (3) were probably built in an existing ditch, which the bridge spanned. Further credence to this is given by the garden plans of Lawrence 1719 and Roque 1735 and 1737. The Lawrence plan shows what appears to be an open ditch draining a lake complex just to the North of where the Atlas pond, 1840, is today. This ditch which was in a similar alignment to the culvert system is not in evidence in either of the plans by Roque in 1735-7 although the lake complex was still there. This would date the main culvert (1) &(2) to between 1719 and 1737.

Fig. 1. Sketch showing bridge-tunnel culvert (2) and relationship with culverts (1) & (3)

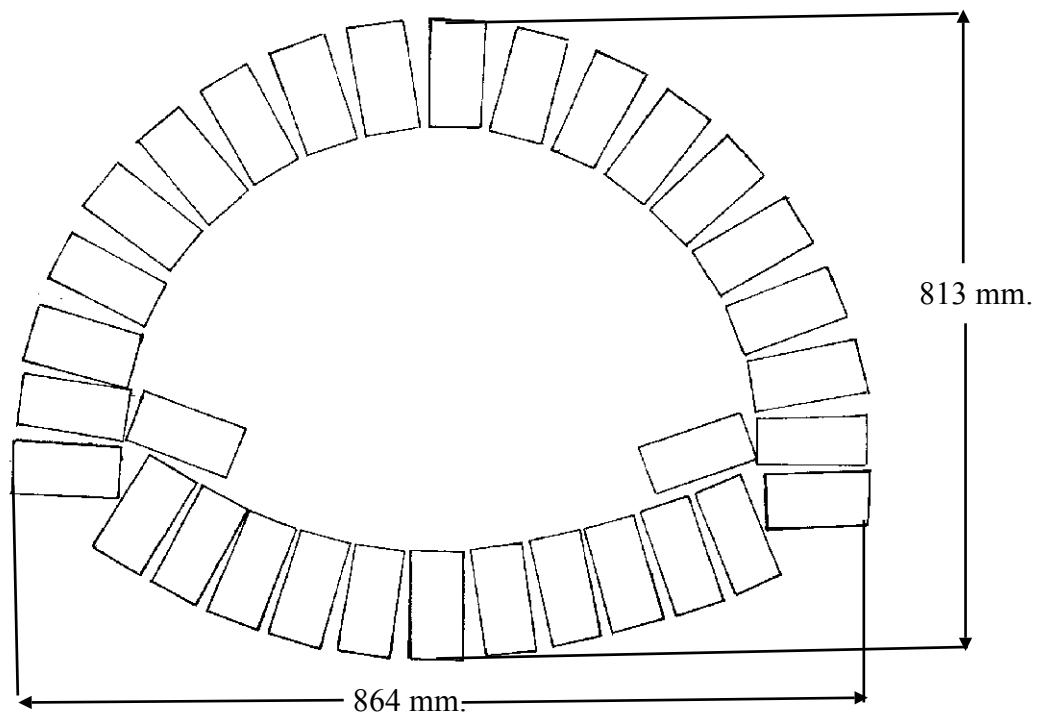
4.3 Excavation at the northern end of the alignment revealed that the culvert had been deliberately destroyed, this was presumably at the time the Atlas Pond was constructed c.1840. The modern turf line just covered the top of the culvert. Bricks had been thrown inside, possibly to block it off. A 125-mm (5-inch) clay pipe drain ran from the collapsed end in a northeast direction towards the eastern ha-ha. An iron grill had been placed across the end of this clay pipe. It was possible to obtain a section of culvert (1) at this point. (figs 2,3 &5).

Fig. 2. Section showing layout of bricks.

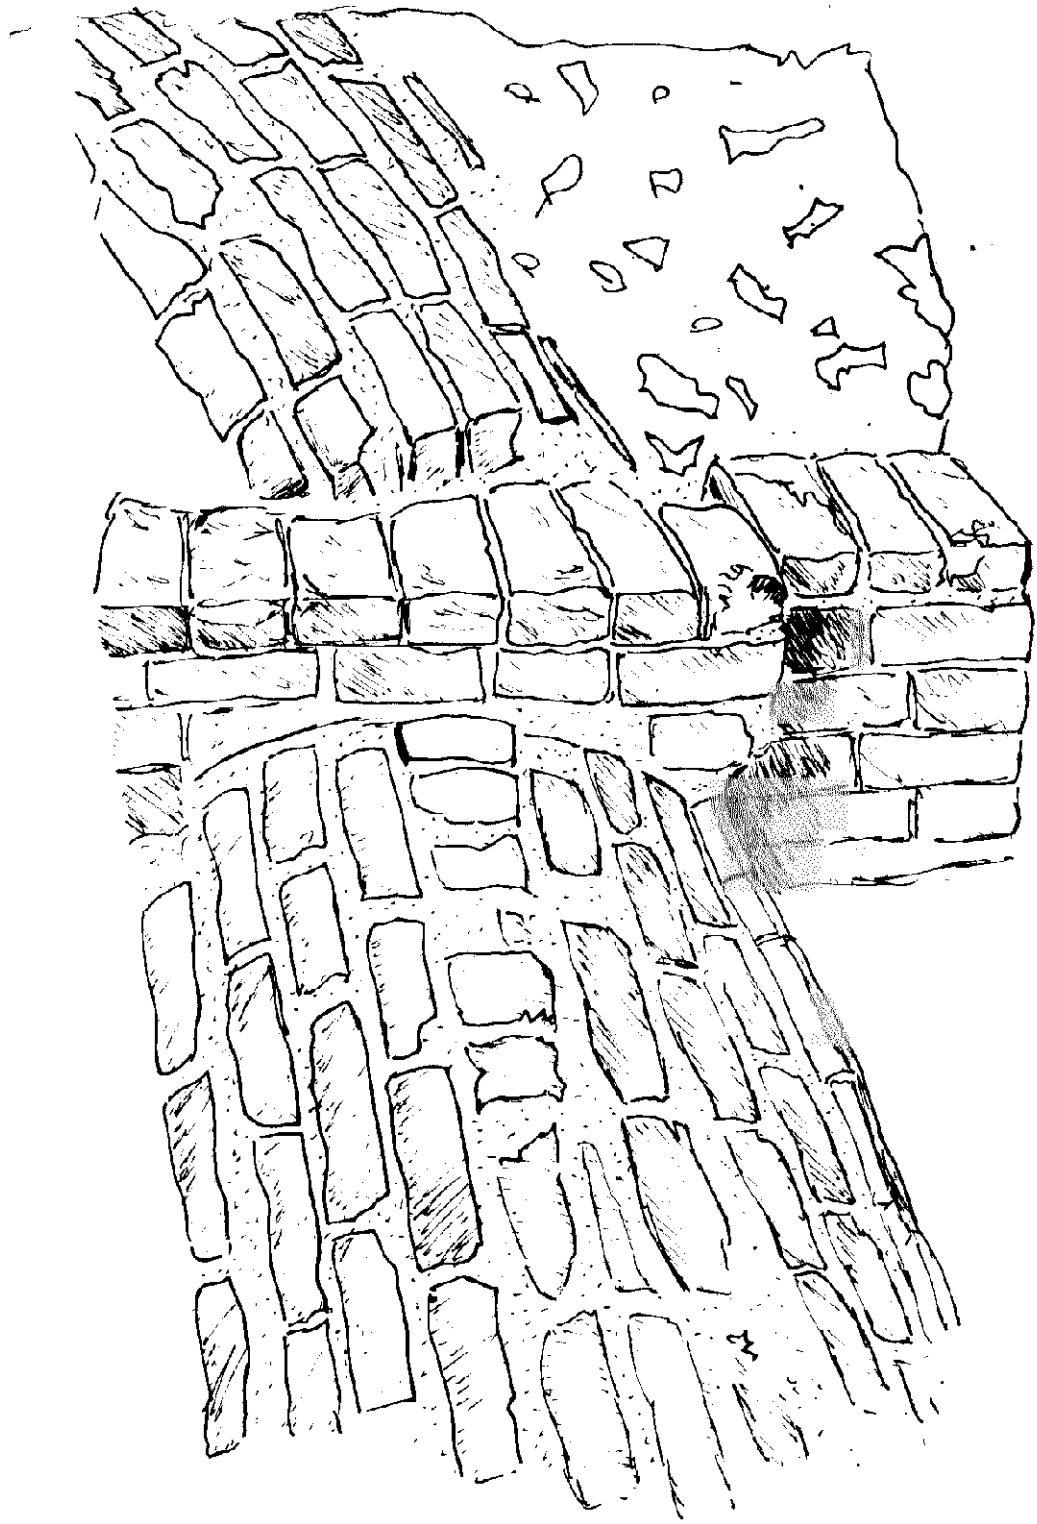
4.2c The join between the culvert (1) and (2) was adequate to hold water but was obviously not built as an entity. The levels at the top did not exactly coincide and the overall quality was not to the standard one would expect. The joints were packed round with gault clay and rubble. (fig.4).

Fig 4. Sketch of exposed culverts (1) (upper) & (2) at join

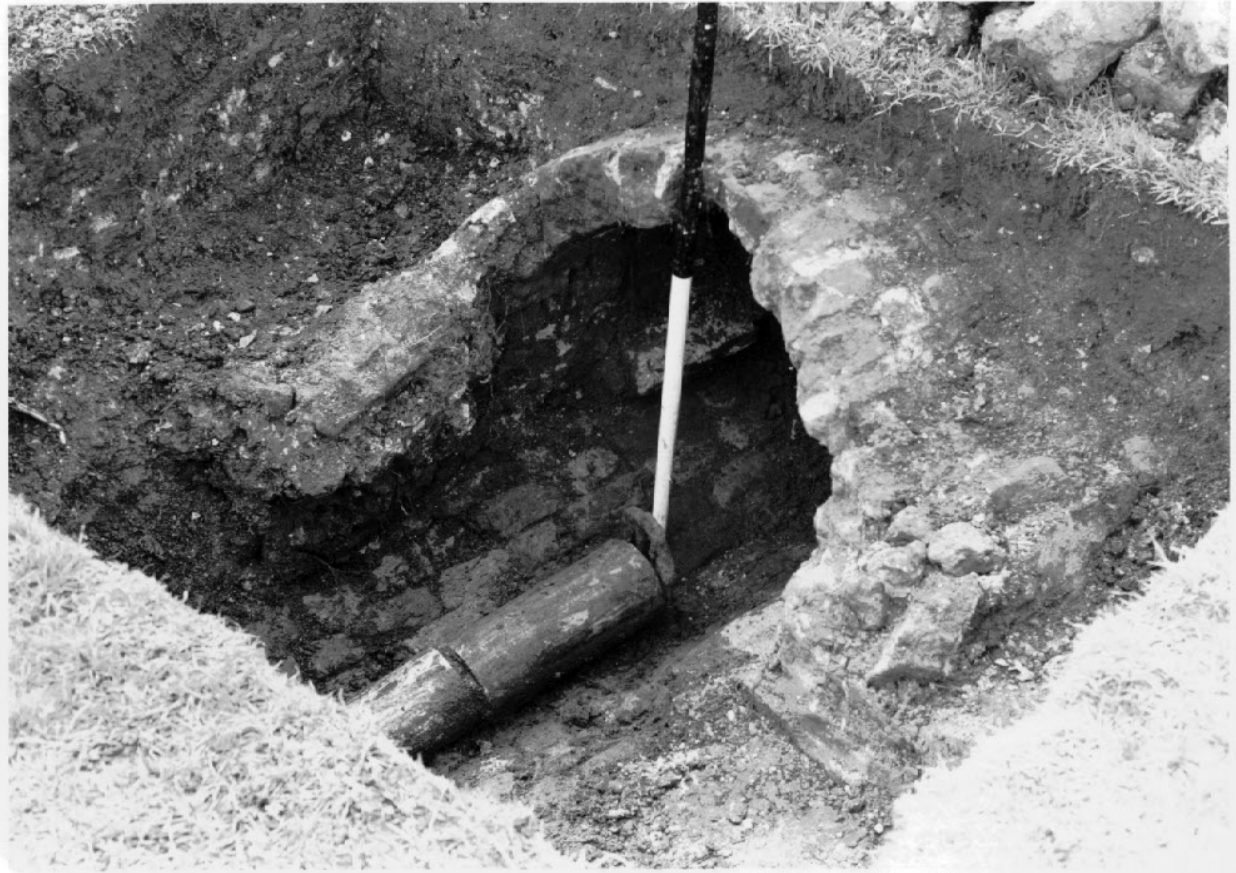
Fig. 5. Collapsed culvert with modern land drain insertion with filter protecting end 4.3.

All the excavations were back filled and re-turfed, it having been decided that, apart from the northern end, the culverts were still of sufficient strength to sustain the likely loads carried during grass mowing etc. The collapsed northern end of the culvert was back filled and covered by a sunken steel plate.

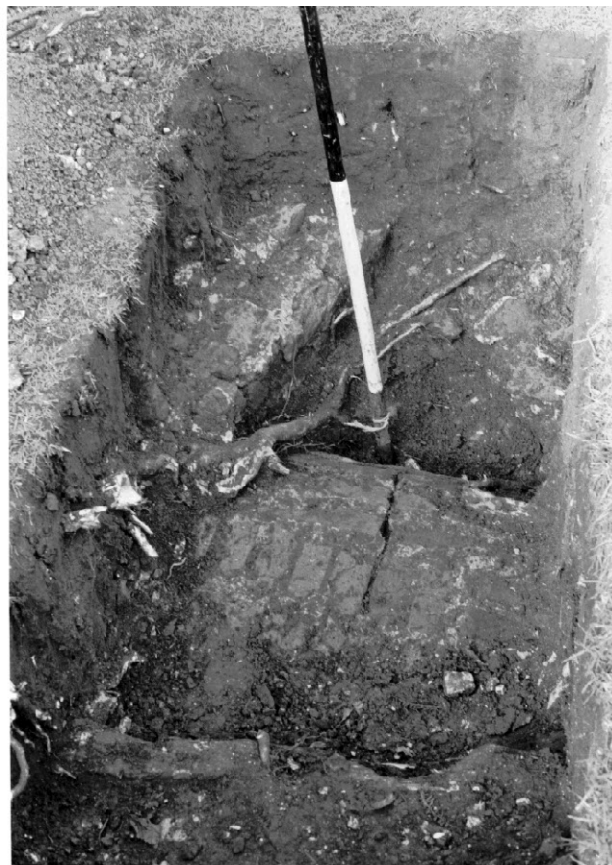
4.4 On the last day of excavation a trial trench was attempted at the point where the culvert approached the yew hedge. A combination of too little time and hedge roots, which we respected, did not allow a thorough investigation. A wall appeared to be running in a northerly direction. The part of the culvert that was exposed had a crack running across it, and bricks were laid at right angles to the general run. (fig.6). The infill round the culvert was also different. Mixed in were several shards of C17th pottery and brick rubble of different quality and size. Fragments of window glass and window glazing lead were in evidence also one piece of soft limestone clunch and several post medieval tile fragments.

Fig. 6. Incomplete trial trench 4.4.

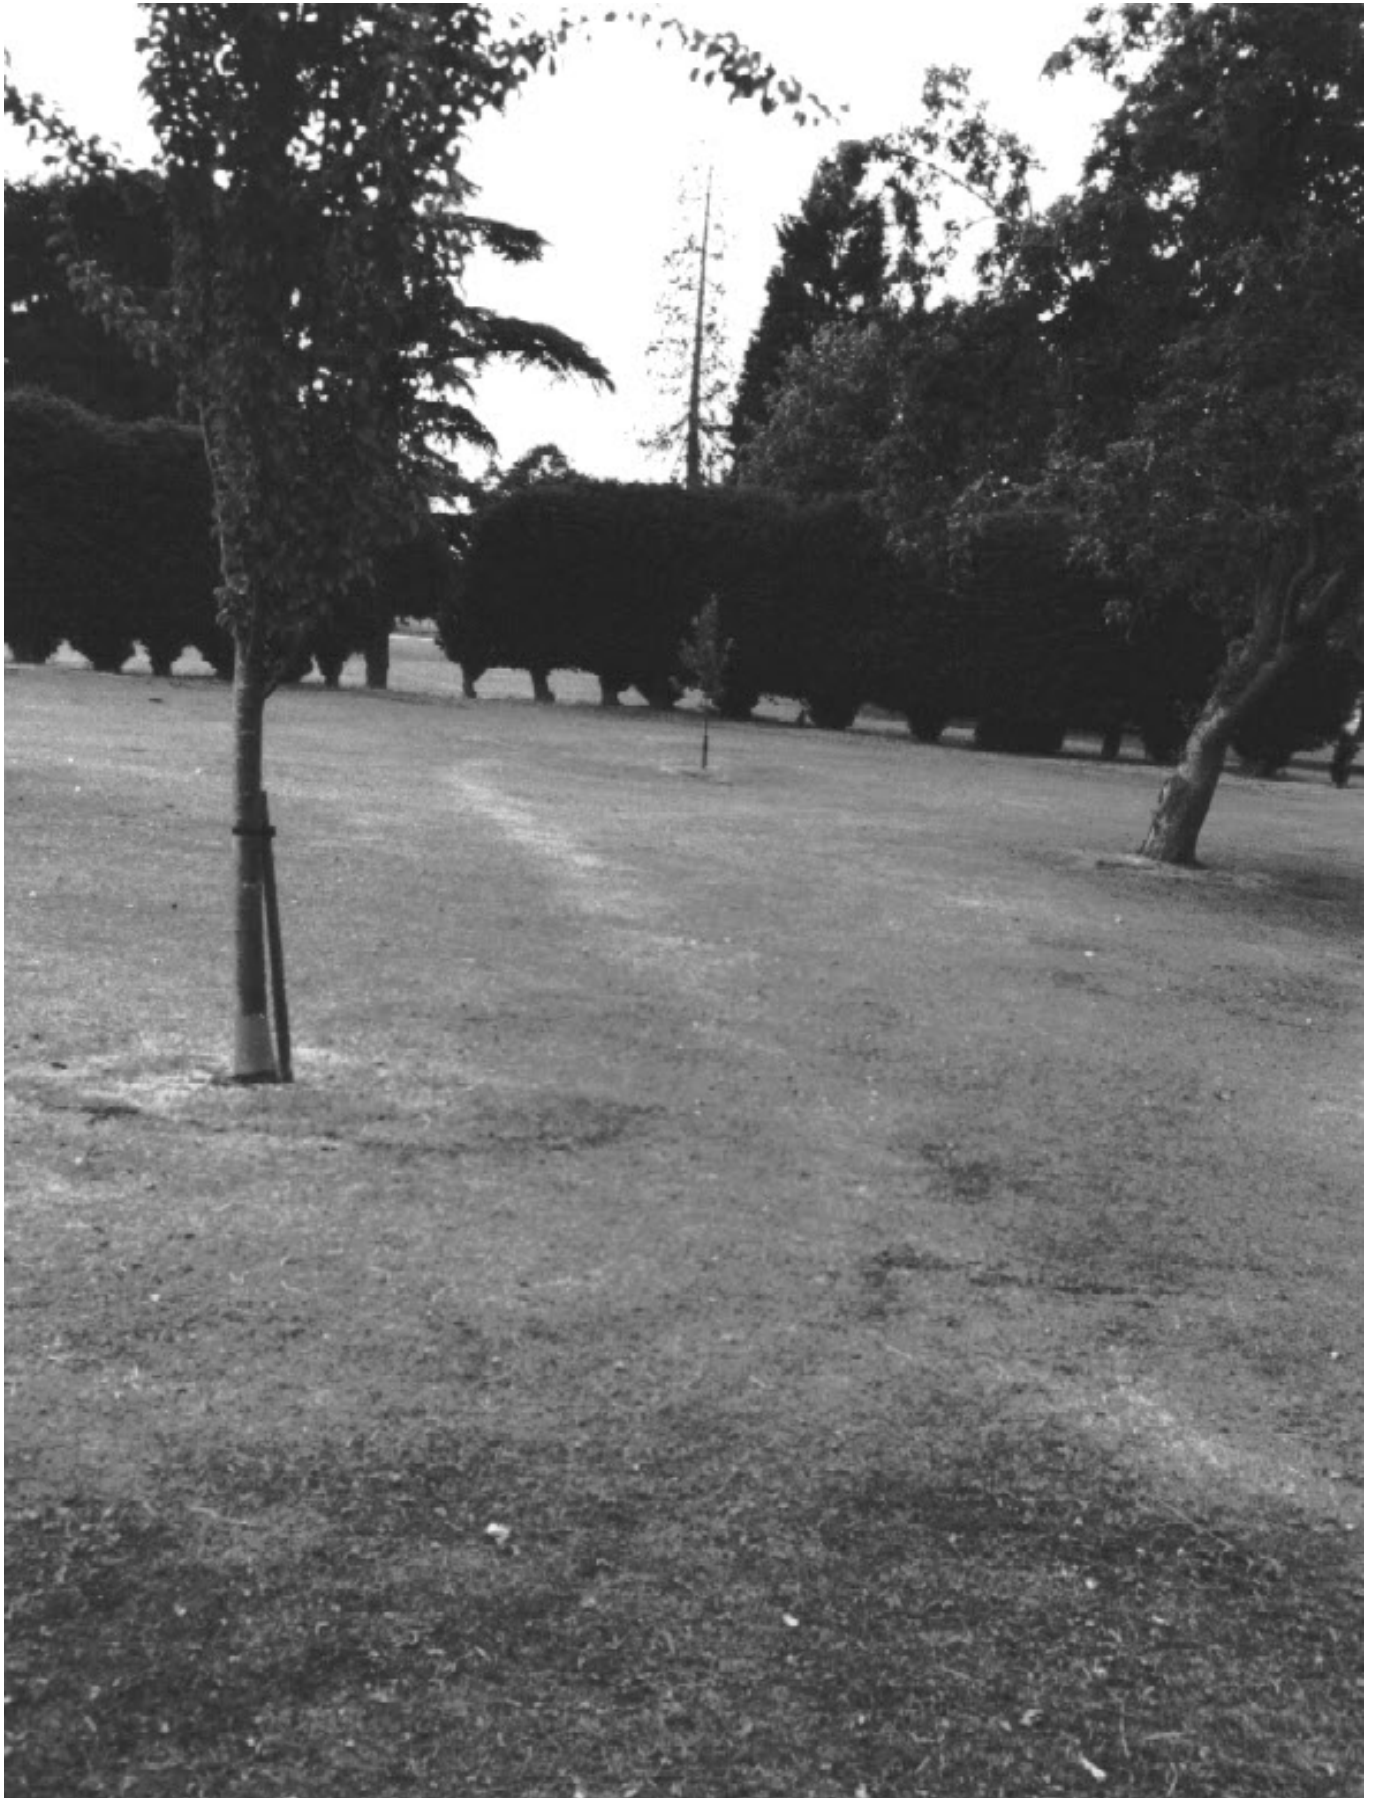
2.2 An opportunity afforded by the very dry autumn of 1996 was taken to look for grass scorching and a photograph showing the apparent line of the culvert was obtained (fig.9).

3.1 With the aid of the photograph taken during the dry period it was relatively easy to plot the alignment of the culvert. It appeared to run straight except for a slight change in direction for approximately three metres before resuming its original direction towards an ancient yew hedge. The depth of probing suggested different heights in the area of the direction change. Probing on the east side of the hedge was very confusing, possibly due to hedge roots. Further probing on the west side of the hedge indicated nothing.

Fig. 9. Photograph showing scorch mark in grass
