**An Archaeological Evaluation of a collapsed
culvert in the gardens of Wrest Park Silsoe
Bedfordshire.**

March 1997

Archaeological evaluation of a collapsed culvert in the gardens of Wrest Park Silsoe.
March 1997

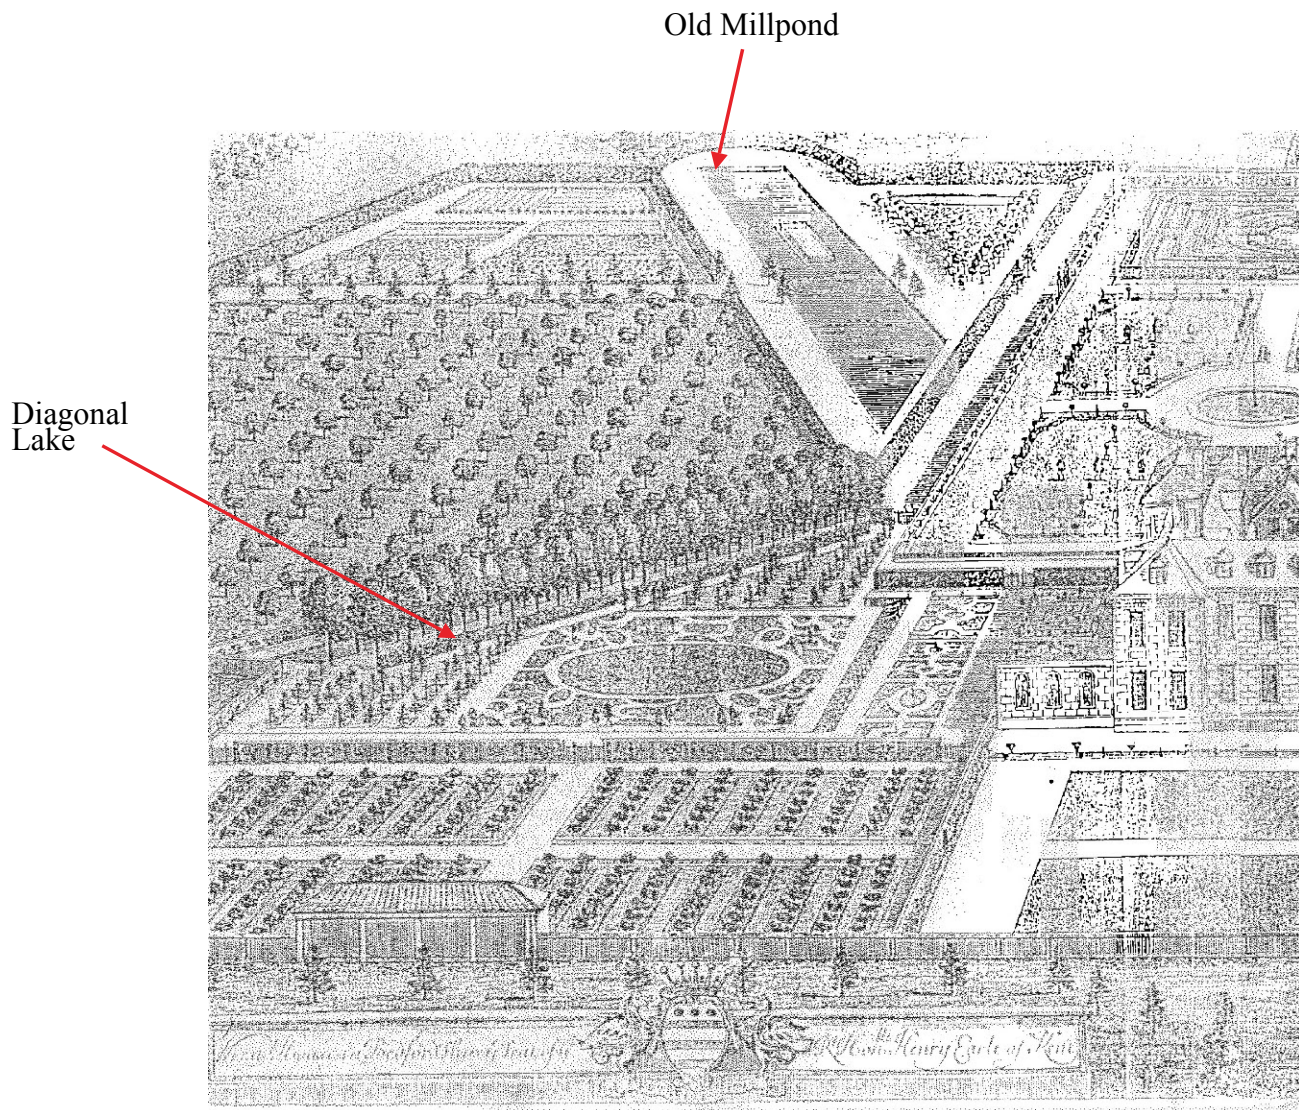
Fig 12 Kip/Knyff Engraving of 1705

Our theory is therefore that the diagonal lake shown on the Kip/Knyff engraving, 1705, would have had an overflow drain to the Old Millpond. When the diagonal lake was filled in, the eastern terrace built, and the new “U” shaped lake formed, then a substantial drain or ditch would still be needed to take away surplus water to the Old Millpond. The open ditch is shown on the Lawrence Map and we presume was converted into a culvert by 1735. This we believe to be the origin of the excavated culverts but without further work it is difficult to say where the culvert goes under the eastern terrace or whether it links up with any storm drains from the Old House complex. fig. 12. Kip/Knyff engraving of 1705.
